FUNDAMENTALS OF INTERFACIAL STRENGTH IN COMPOSITE MATERIALS

ANNUAL REPORT 1 JULY 1986 - 30 SEPTEMBER 1987

A.W. Thompson and I.M. Bernstein Principal Investigators

Report No. MEMS-ALC-11 16 November 1987

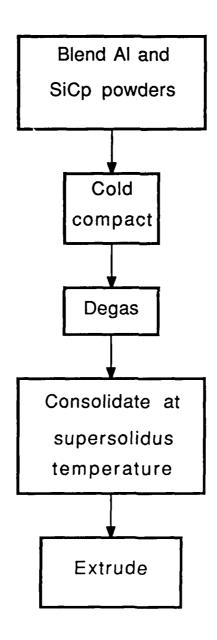
DWA Al-SiCp Processing Steps

Two Al-SiC_p composites are being investigated in this study. The Al alloy matrices of the composites are 6061 (Al-Mg-Si) and 7090 (Al-Zn-Mg-Cu). Both composites are reinforced with 20 v/o particulate $\alpha\text{-SiC}$ (SiC_p). The " α " designation indicates that the crystal structure of the reinforcement is mostly the hexagonal α phase. The average particle size in the 6061-SiC_p composite is 3-4 μm . In 7090-SiC_p, there is a bimodal SiC size distribution, with a large peak at 3 μm and a smaller, broad peak at 9-11 μm . DWA Composite Specialties, Inc. manufactures both composites by the P/M process illustrated in Figure 1.

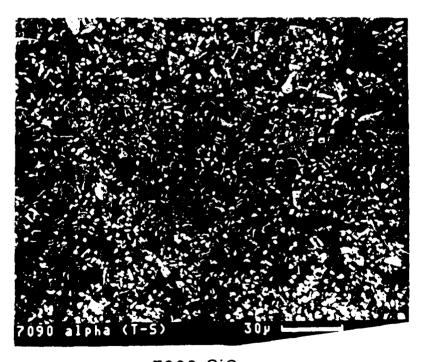
Figure 2. Composite T-S metallographic plane

6061-SiC

7090-SiC

Representative microstructures of the as-received composites are shown in Figure 2. These photographs are from the T-S plane, perpendicular to the extrusion direction. Figure 3 presents the area fraction of reinforcement for each composite on three planes through a metallographic specimen. There appears to be some particle alignment with the extrusion direction in 6061-SiC_p . It should be noted that the particles are not spherical, but the aspect ratio is usually less than three.

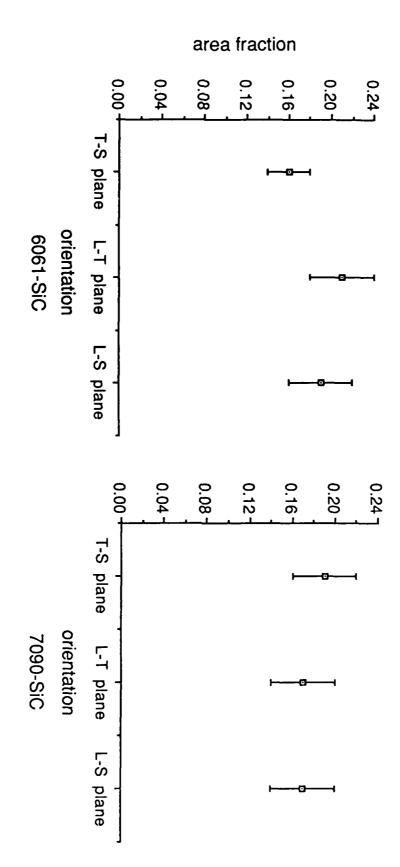
Figure 3. Area fraction SiCp in as-received composites

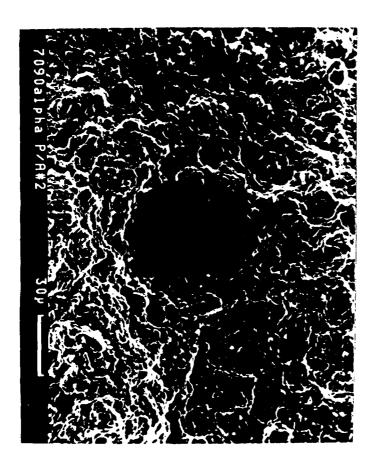
Figure 4. Fracture initiation site at intermetallic particle in 7090-SiC

Fracture initiation in both composites occurred most often (eight of eleven tensiles) at large intermetallic particles. Figure 4 shows a fracture initiation site in 7090-SiC_p . The intermetallics ranged in size from 45-150 μm . These intermetallics are the result of DWA's processing technique. Consolidation of DWA's composites is conducted at supersolidus temperatures; local melting occurs in the matrix, which allows intermetallic phases to form. Alcoa also makes P/M composites of this general type, but their processing method utilizes consolidation at sub-solidus temperatures. Tensile fracture in Alcoa specimens usually initiates at clusters of SiC particles or a very large reinforcement particle--rarely at intermetallics.

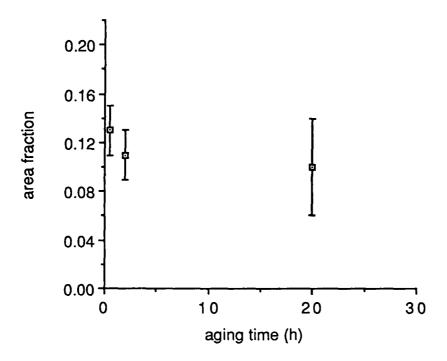
Figure 7. Cracked SiC on 6061-SiC fracture surfaces

Quantitative analysis of the fracture surfaces was performed to examine the area fraction of cracked SiC_p on the fracture surface. Figures 7 and 8 show the results obtained for the various conditions of the composites. In both $6061\text{-}SiC_p$ and $7090\text{-}SiC_p$, the area fraction of cracked SiC particles on the tensile fracture surfaces decreased as the material was aged. Work by Lewandowski, Liu, and Hunt(1) showed that in a matrix alloy very similar compositionally to 7090, a brittle precipitate forms at the SiC particle/matrix interface in the overaged condition (Figure 9). We believe that this is also occurring in $6061\text{-}SiC_p$ and $7090\text{-}SiC_p$. In the under-aged and peak-aged condition, a crack traveling through the material would find it easier to

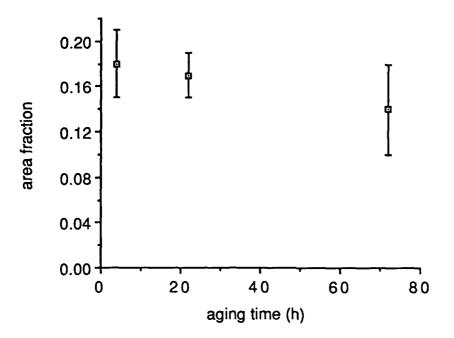
Figure 8. Cracked SiC on 7090-SiC fracture surfaces

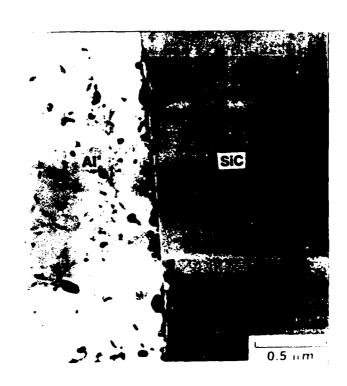
Figure 9. TEM micrograph showing η(MgZn₂) precipitates at the SiC particulate/MB78 matrix boundary in the T7X3 (over-aged) condition (from Lewandowski, Liu and Hunt, *Microstructural Effects on the Fracture Micromechanisms in 7xxx Al P/M-SiC Particulate Metal Matrix Composites*, Alcoa Laboratories Technical Report, June 19, 1987)

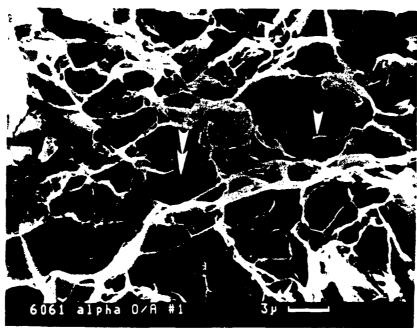
Figure 10. Matching tensile fracture halves of over-aged 6061-SiC; decohered particle and its cavity indicated by arrows

propagate through particles in its path rather than around them. When precipitation occurs at the interface, propagation through the brittle precipitate may be easier than through the SiC particle. This explains why the area fraction of cracked SiC on the fracture surfaces decreases in the over-aged condition; more decohesion of particles from the matrix is occurring. Figures 10 and 11 show instances of decohered particles in the over-aged composites.

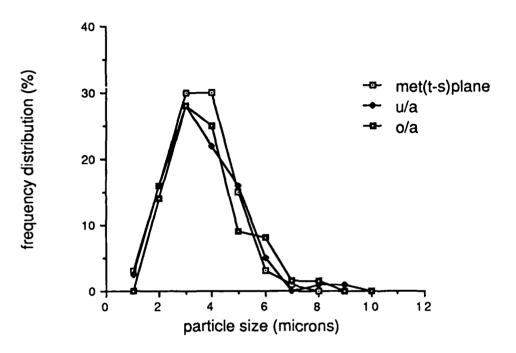
Figure 12. Frequency distribution of cracked particle sizes on fracture surfaces of 6061-SiCp

The tensile fracture surfaces of both composites were quantitatively examined to determine the frequency distribution of particle sizes for the cracked SiC particles on the fracture surfaces. For 6061-SiC_p (Figure 12), the cracked particle size distribution on the fracture surfaces was similar to the size distribution found on a T-S plane through a metallographic specimen for both under-aged and over-aged conditions. The situation is somewhat different for 7090-SiC_p (Figure 13). First, the proportion of large SiC particles found on the tensile fracture surfaces is higher than the proportion of large particles found on a T-S plane through the as-received material. (Recall that 7090-SiC_p has a bimodal particle size distribution.) Lewandowski, Liu, and Hunt(2) have proposed that this may be due to the greater probability of finding critically sized defects in the larger particles. Second, the proportion of cracked smaller particles on the fracture surfaces decreases as the 7090-SiC_p composite is aged. This may indicate that the matrix begins to play a more dominant role in the fracture process as precipitation occurs in the matrix during overaging. More tests will be necessary to confirm this.

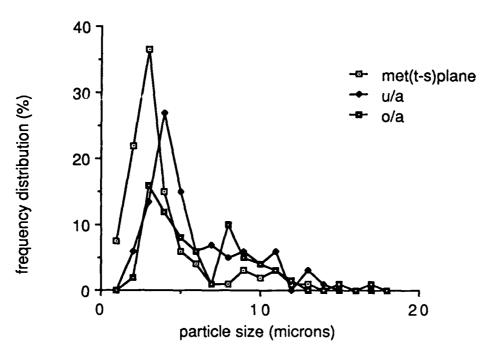
Figure 13. Frequency distribution of cracked particle sizes on fracture surfaces of 7090-SiCp

The matrix appears to play a more dominant role in failure of 7090-SiC_p than of 6061-SiC_p . Size proportions of cracked SiC particles in over-aged and under-aged conditions of 6061-SiC_p fracture surfaces were similar to those proportions found in the asreceived composite. In 7090-SiC_p , the proportions changed with heat treatment.
